Tan-y-Deri Comprehensive Restoration

Farm Wing Roofing Restoration

Taliesin Preservation Inc. Proposed Method Of Approach

400-1001 Project Adendum 1

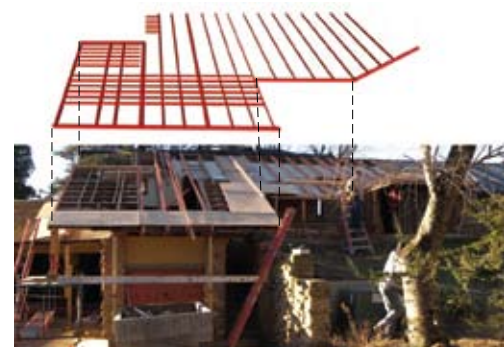
Schematic solution to carry the structural failure. The members in red represent micro lams added to augment the existing structure.

The preservation team chose an approach that preserved both the original design intent and the maximum amount of historic fabric by augmenting the existing structure with micro lams sistered to the rafters; strengthening the existing triangular soffit construction by sistering micro lams on the flat across the historic half lapped grid work running east to west; and gusseting the triangular braces. The west portion of the roof above the entry stairs had to be reconstructed due to multiple failures. A double micro lam with a fitch plate was installed to carry the load of the front fascia, above the barn doors. All of these framing was then integrated with 3/4" tongue and groove plywood that was screwed and glued to the micro lams. Fiberglass reinforced rubberized bituminous felt was installed as the underlayment for the cedar shingles. This work will continue through the winter with interior finishes restored as needed and insulation added where possible.

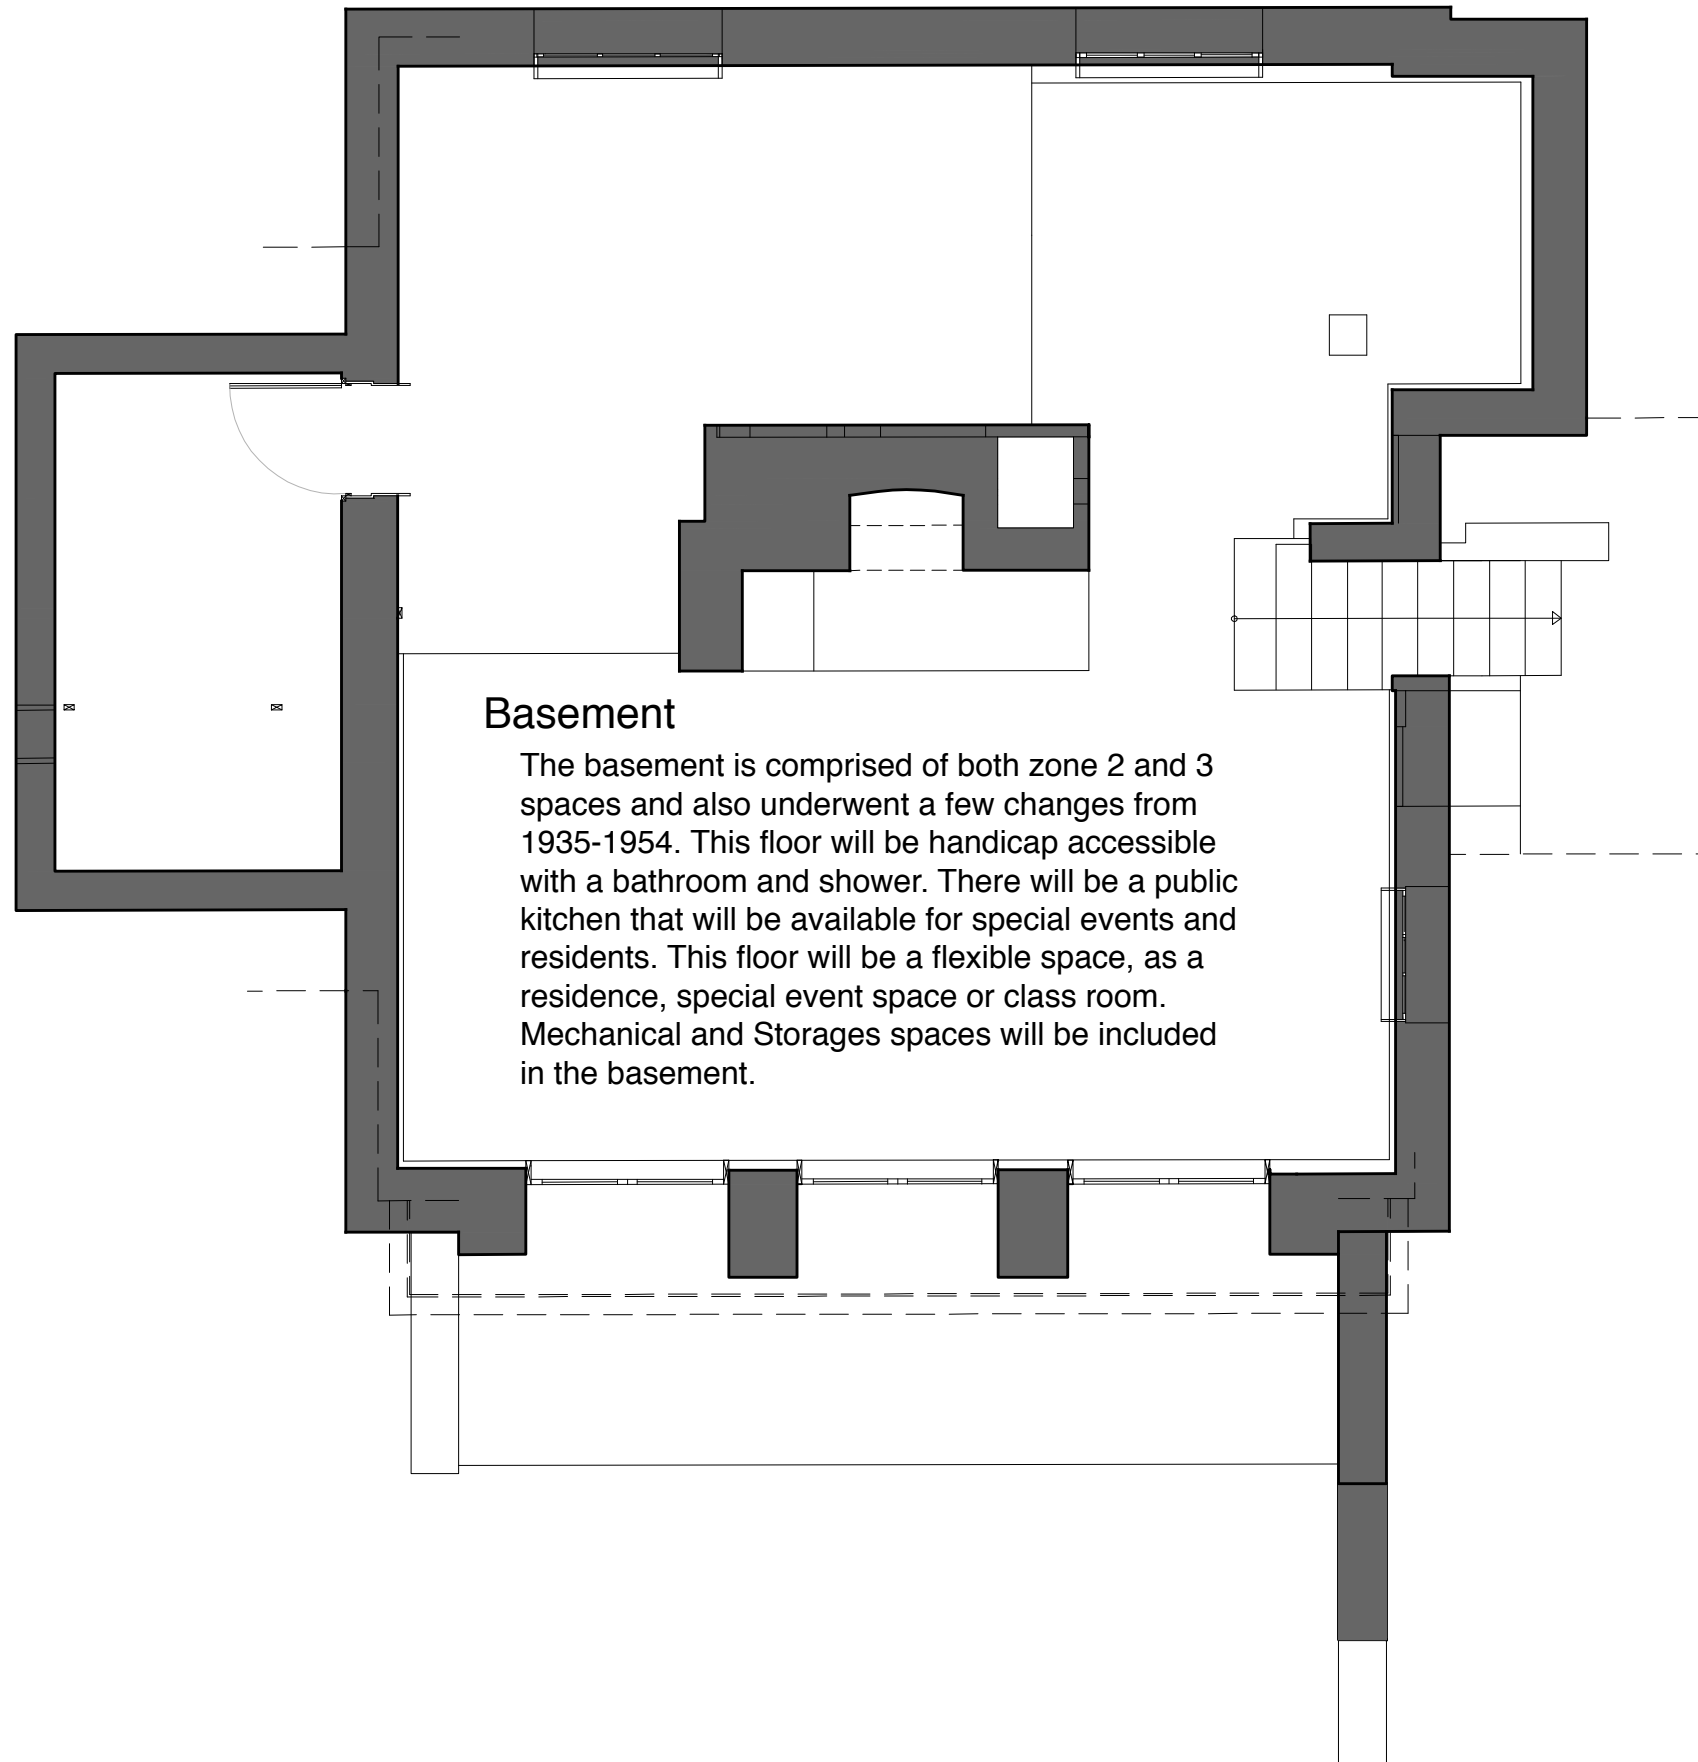
Basement

The basement is comprised of both zone 2 and 3 spaces and also underwent a few changes from 1935-1954. This floor will be handicap accessible with a bathroom and shower. There will be a public kitchen that will be available for special events and residents. This floor will be a flexible space, as a residence, special event space or class room. Mechanical and Storages spaces will be included in the basement.

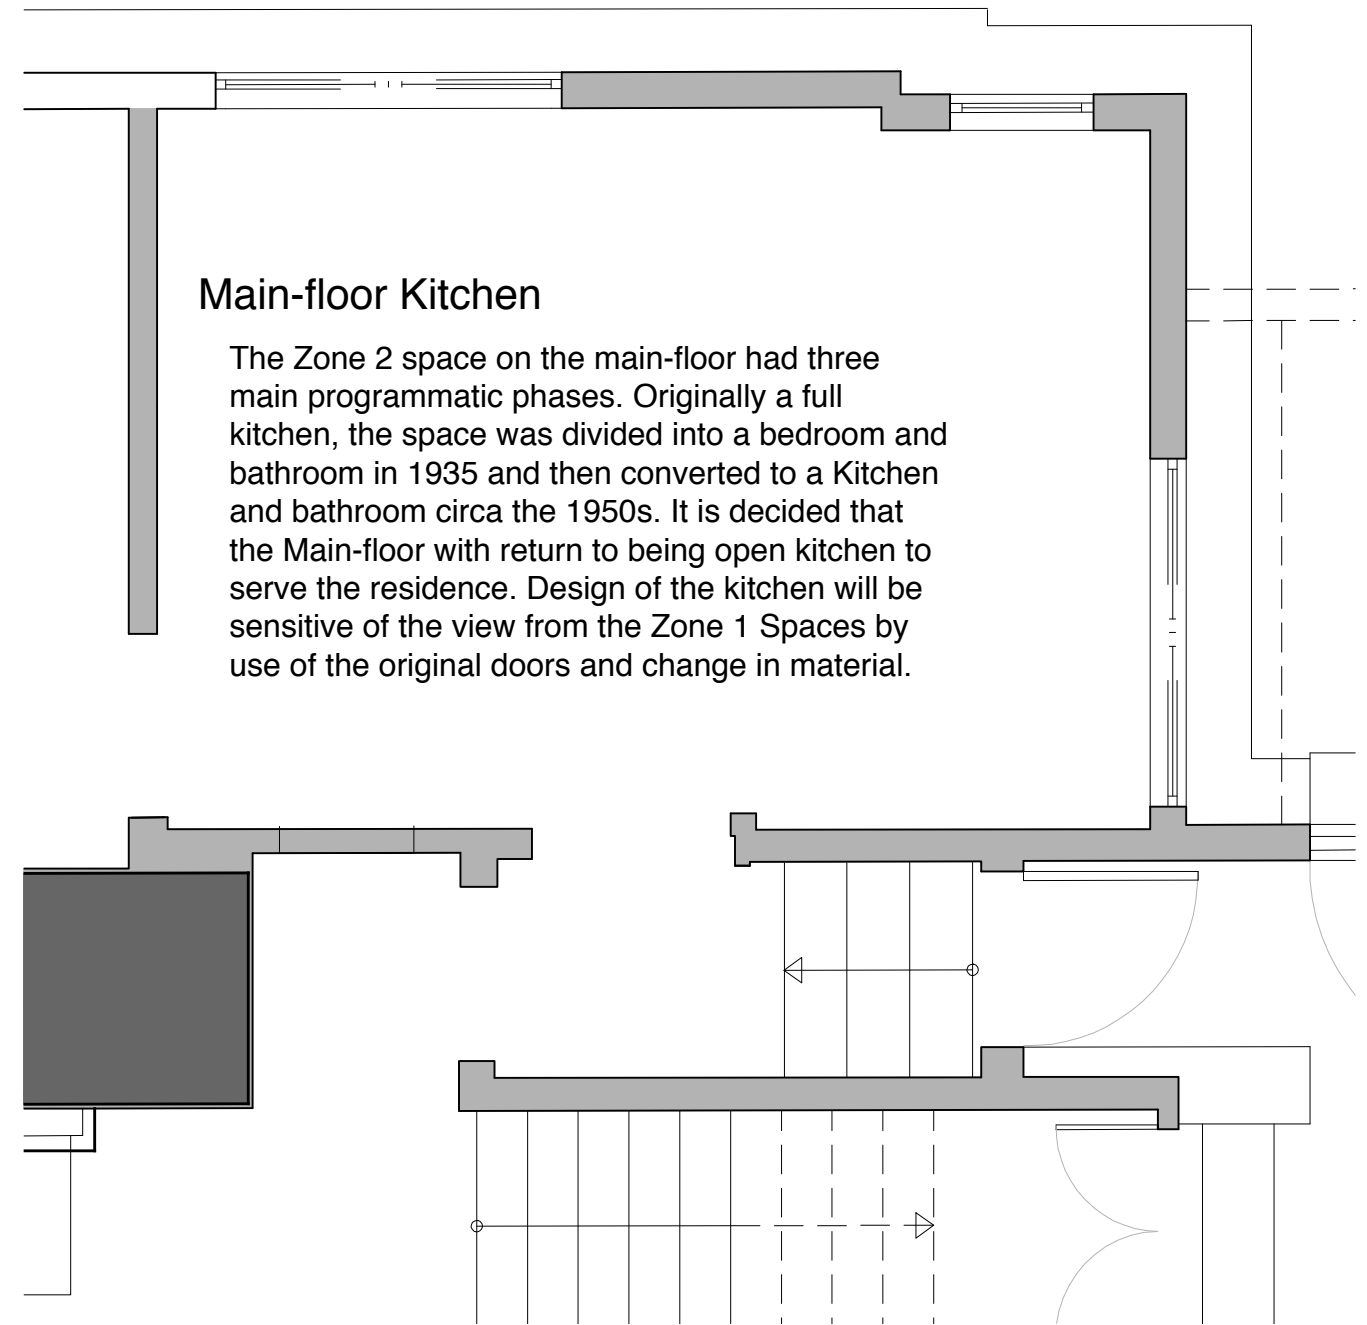
Main-floor Kitchen

The Zone 2 space on the main-floor had three main programmatic phases. Originally a full kitchen, the space was divided into a bedroom and bathroom in 1935 and then converted to a Kitchen and bathroom circa the 1950s. It is decided that the Main-floor will return to being open kitchen to serve the residence. Design of the kitchen will be sensitive of the view from the Zone 1 Spaces by use of the original doors and change in material.

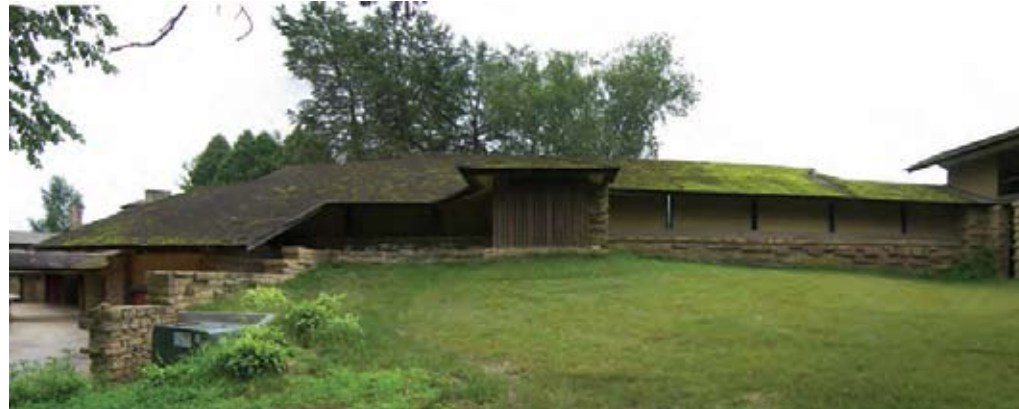
West Wing before restoration work.

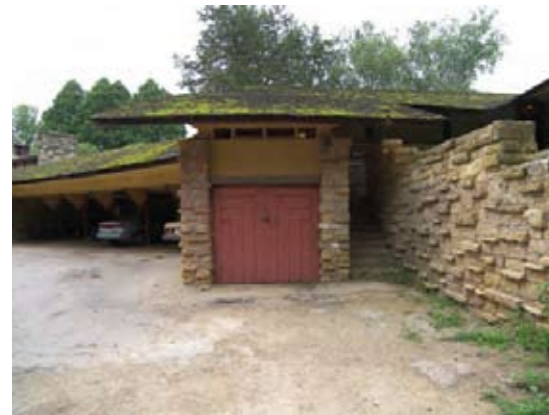
One of the most seriously deflected soffits in need of structural rehabilitation. The above roof cantilevers to the front and side elevations.

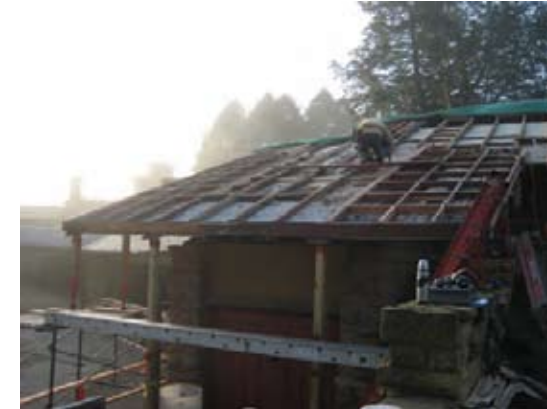
Existing framing condition. The left side of the roof was framed using half lapped notched members to counteract the force of gravity on the overhang.

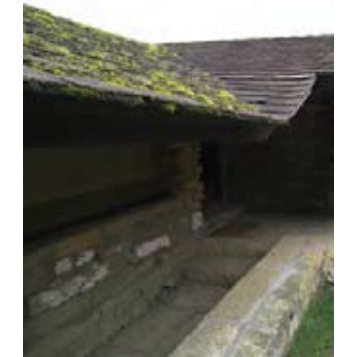
Ridge and framing condition above

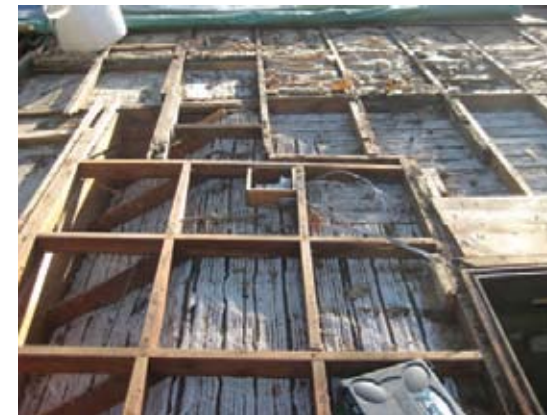
Detail of existing framing. Upper right hand corner shows evidence of an earlier fascia line. This is the right side of the roof shown above- this cantilever was supported by horizontal blocking that resulted in significant failure.

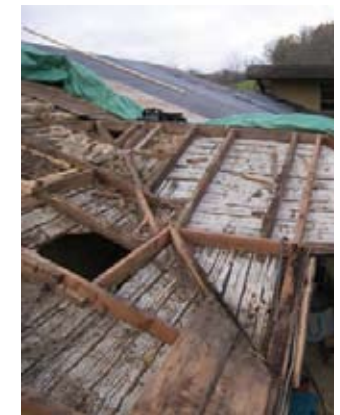
View of hipped roof at entry the f... continuous members and the disc... was replaced with a micro lam.

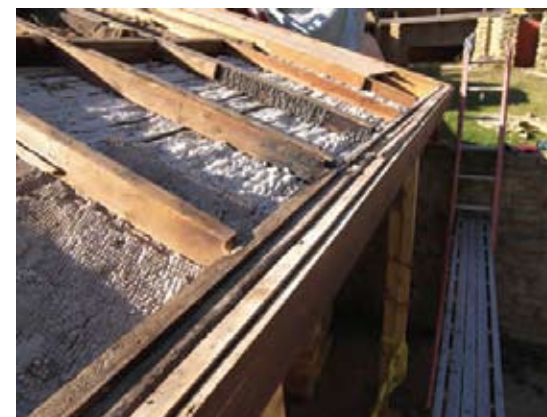
Fire damage to the fascia and rafters.

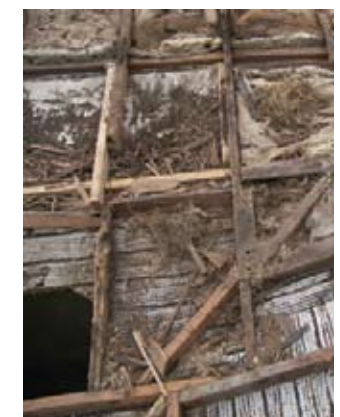
View of the failed valley at the en...

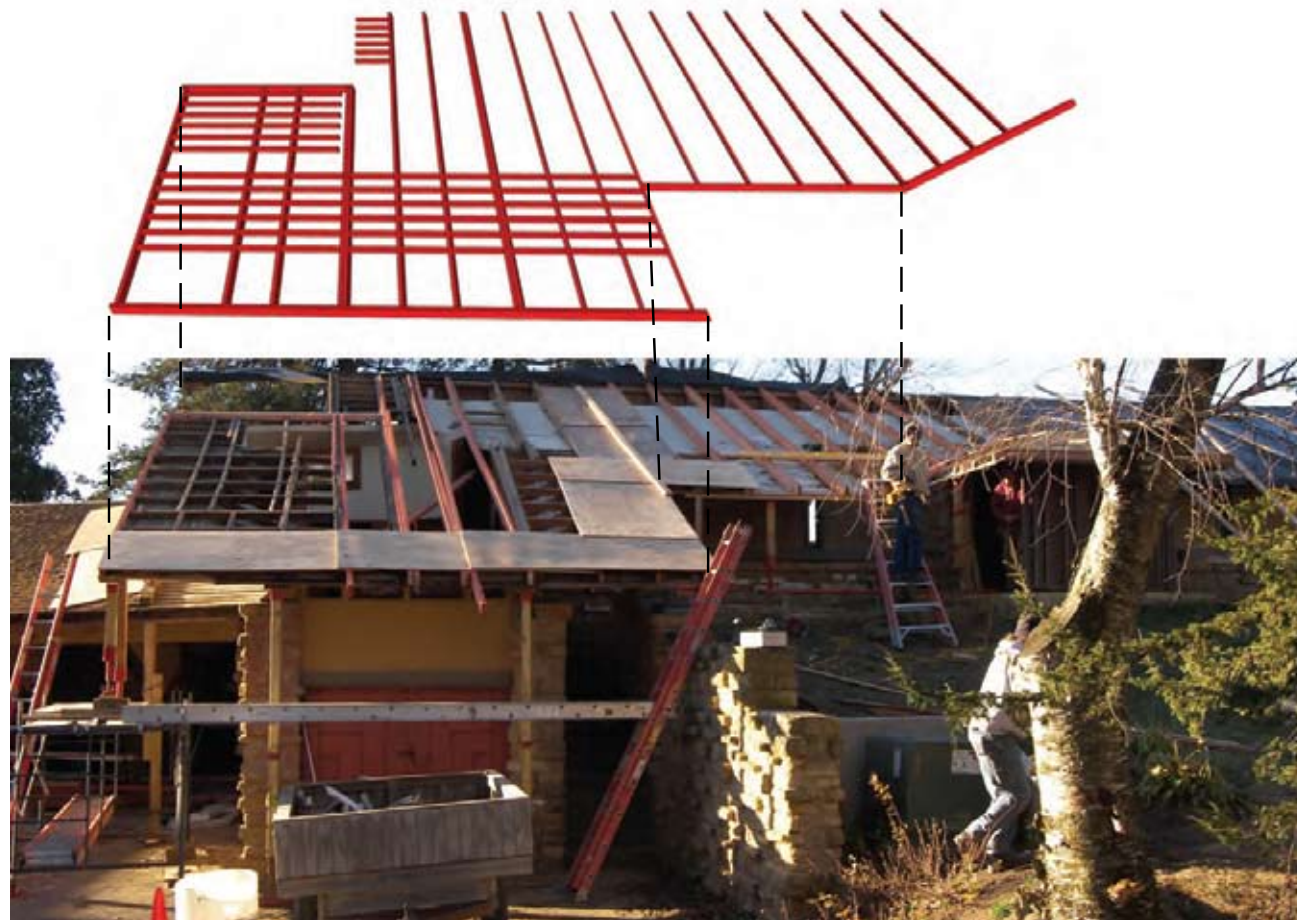
Schematic solution to correct the structural failure. The members in red represent micro lams added to augment the existing structure.

The preservation team chose an approach that preserved both the original design intent and the maximum amount of historic fabric by: augmenting the existing structure with micro lams sistered to the rafters; strengthening the existing triangular soffit construction by sistering micro lams on the flat across the historic half lapped grid work running east to west; and gusseting the triangular braces. The west portion of the roof above the entry stairs had to be reconstructed due to multiple failures. A double micro lam with a fitch plate was installed to carry the load of the front fascia, above the barn doors. All of these framing was then integrated with 3/4” tongue and groove plywood that was screwed and glued to the micro lams. Fiberglass reinforced rubberized bituminous felt was installed as the underlayment for the cedar shingles. This work will continue through the winter with interior finishes restored as needed and insulation added where possible.

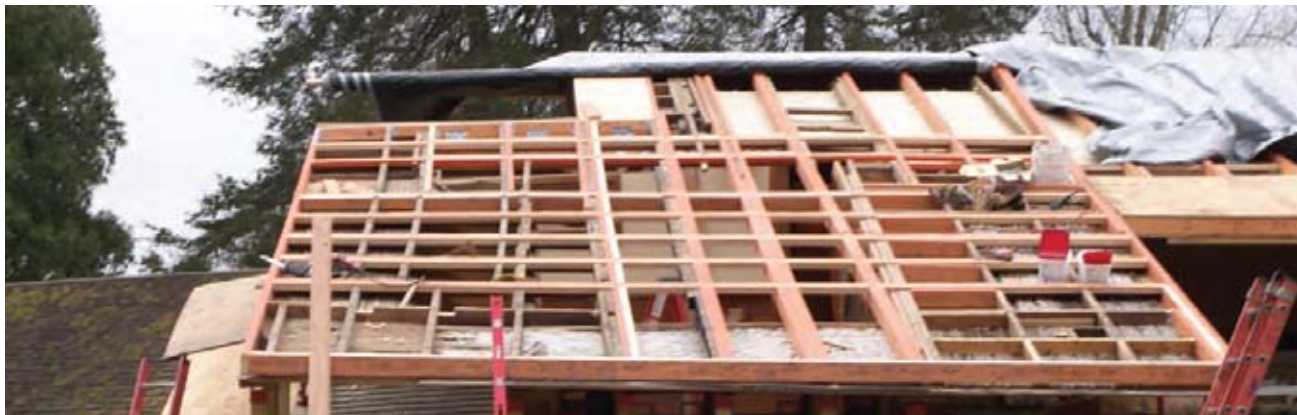
Sistering/structural augmentation complete. The intention of this effort was to stiffen the structure in both directions-similar to an airplane wing.

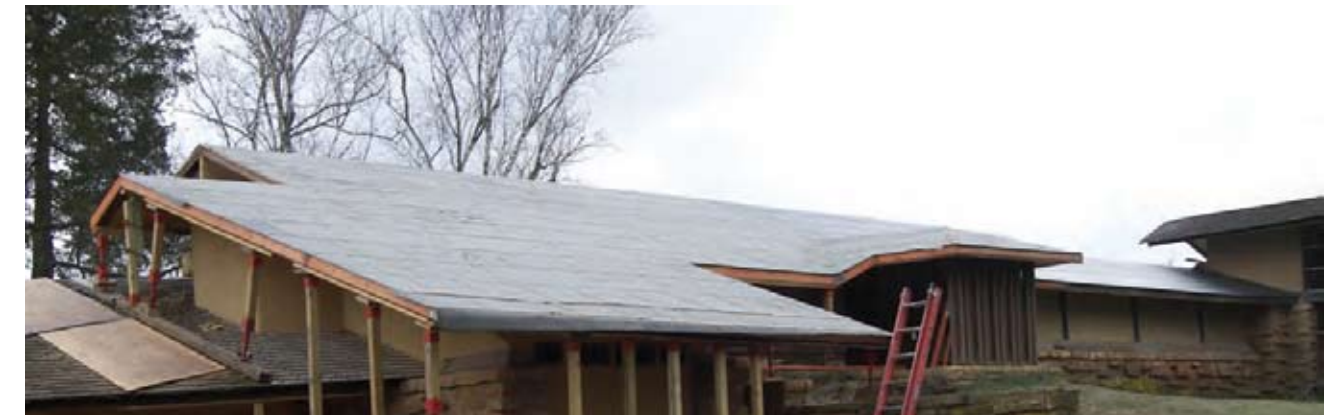
View towards the entrance of the West Wing, all structural repairs have been made, and the roof is ready to receive the cedar shingles.

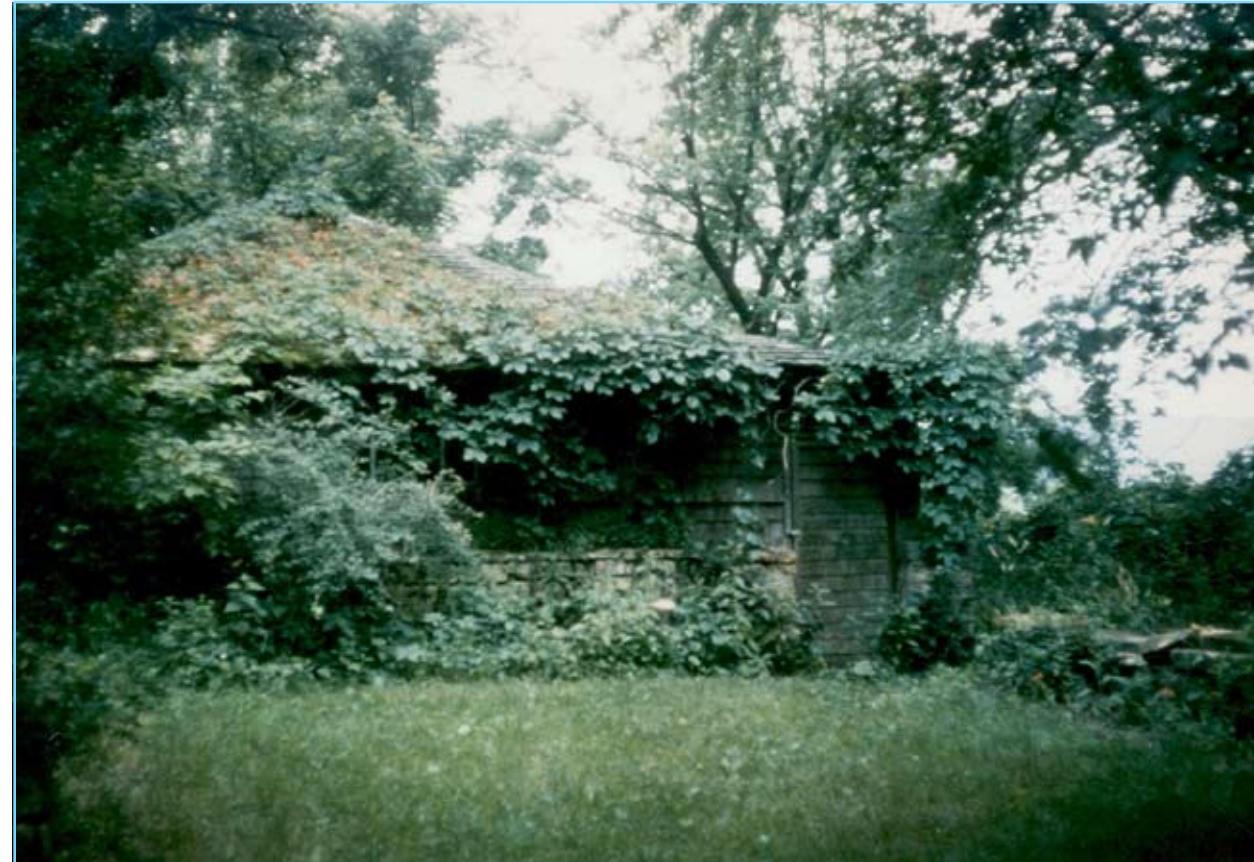
#144

#144: THE STONE
WALL THAT IS STILL
CURRENTLY THERE
IS TO THE RIGHT
AND AT SOME
POINT AFTER THIS
PHOTO THE STONE
FOUNDATION WAS
REMOVED.
